Client: Council of City of Sydney

Product: Headingly 900mm high with plain spear picket.

Installation Date March 2004

Review date: March 2014

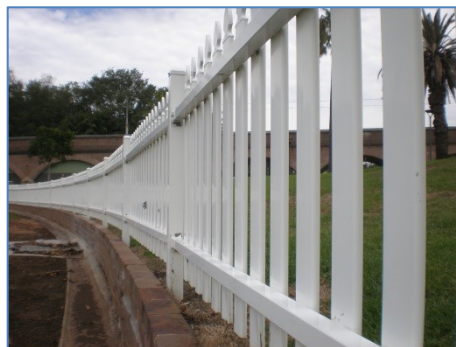
The fencing after 10 years in 2014

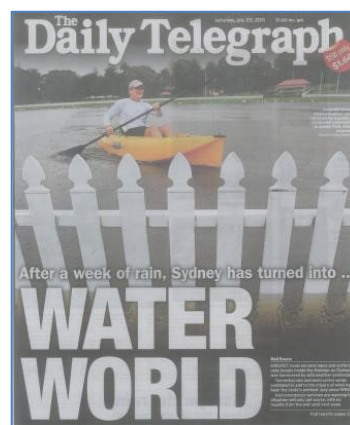
The fencing shown in 2011 on the front page of *The Daily Telegraph*.

- The oval is low lying and is some 20 metres from Sydney Harbour. In the corner close to the Harbour there is a storm water drain. During 'king' tides and flooding water rises up through this drain and results in a about 100 metre section of the fencing being submerged (see the image above). This water obviously has a salt content that encourages corrosion of the steel materials.

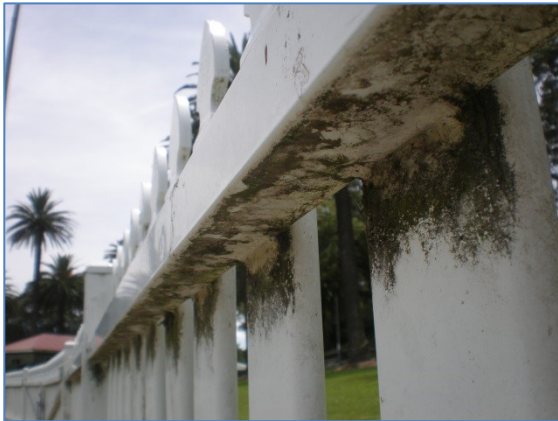
The accumulation of grime under the rail suggests the fence has probably not been cleaned since installation.

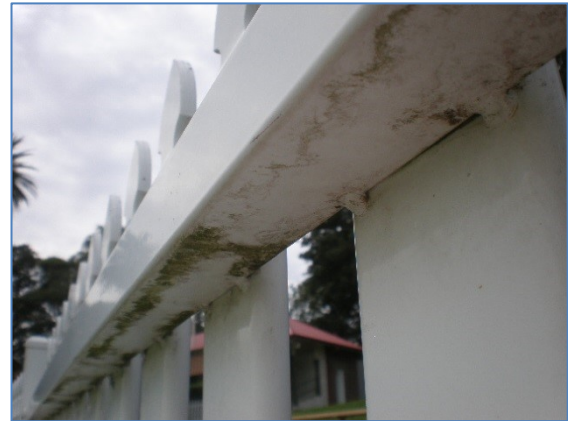
After a good clean the gloss of the pearl white coating and film integrity is apparent.

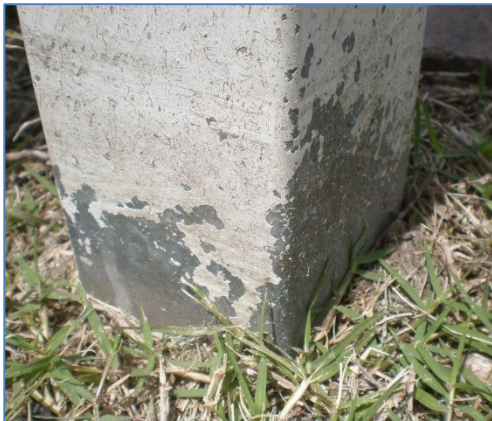
This image shows a fence post and the impact of repeated grass cutting around the post. It demonstrates the durability of the coating and the corrosion resistance of the coating and steel.

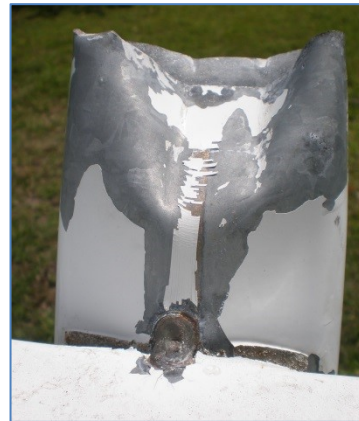
This image shows a picket that has been seriously deformed by some means. It demonstrates the strength of the steel picket and weld that the picket is still held to the rail.

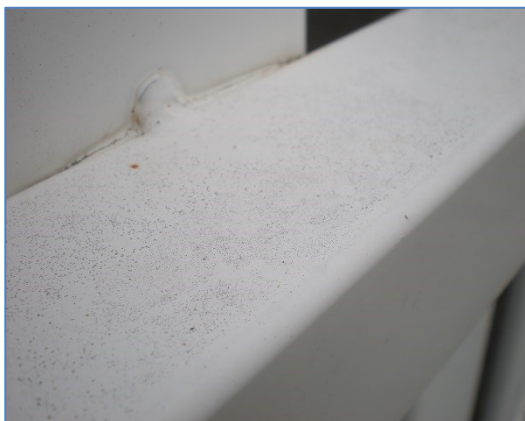
- The powder coating has still retained much of its pearl white gloss.
- There is practically no deterioration in the integrity of the coating. There is some isolated pin holing but no chalking or cracking.

This image shows a close up of the coating (after cleaning) on the top of the rail. Some small pin holing is present however there is no evidence of cracking, chalking or delamination.

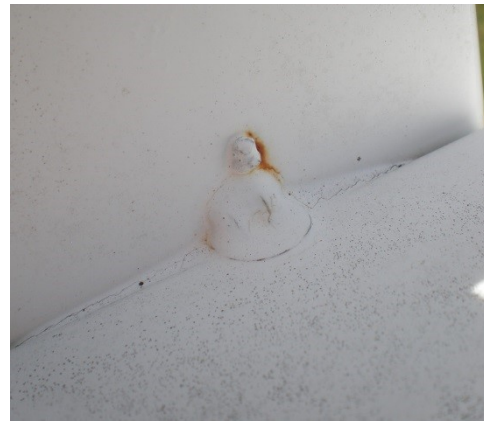
- The superior corrosion resistance of silicon bronze weld is apparent as there is virtually no corrosion around the weld.
- The durability of the coating is apparent from the every day wear and tear that the fence has been subject to over the 10 years.

This image shows a close up of the coating (after cleaning) on the top of the rail. A small amount of corrosion is visible next to the silicon bronze weld.

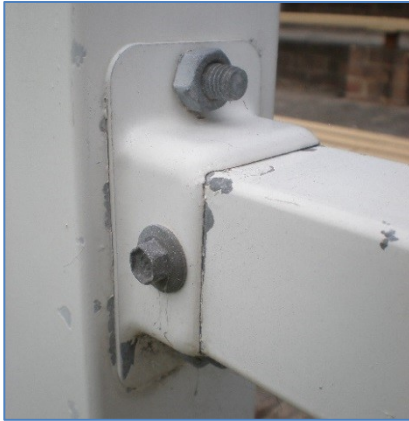
- There has been minimal corrosion around the zinc plated shrouds used to secure the panels to the posts. Where these zinc plated shrouds have been submerged.

This image (after cleaning) is representative of the condition of the zinc plated shrouds.

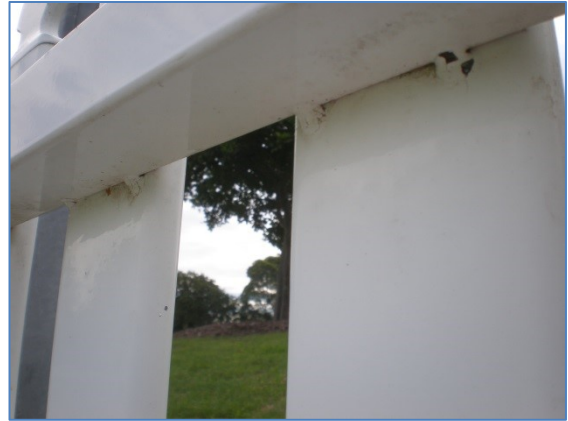
This image (after cleaning) is representative of the condition of the coating on the underside of the rail. The gloss is still apparent.

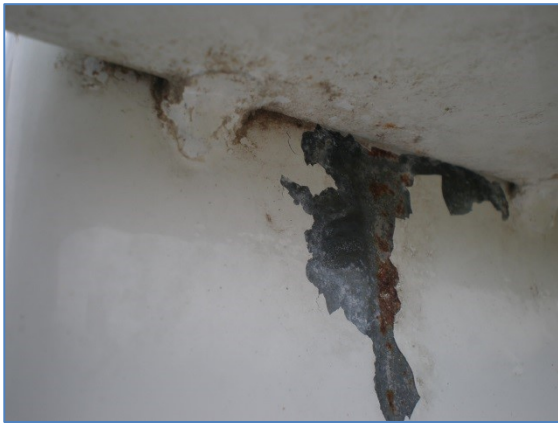
This image shows a close up of the coating (after cleaning) on the bottom of the rail. This is a section of fencing that is periodically submerged in tidal waters. The barrier corrosion protection of the powder coating and the sacrificial protection of the zinc coating on the steel is apparent.

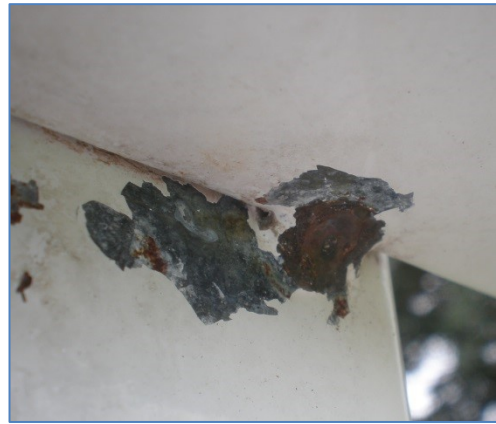
This image shows a close up of the coating (after cleaning) on the bottom of the rail. It shows similar protection to the image at left.

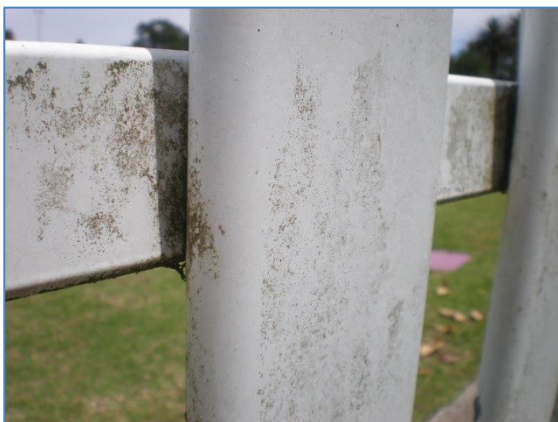
This image shows the face of picket fencing prior to cleaning.

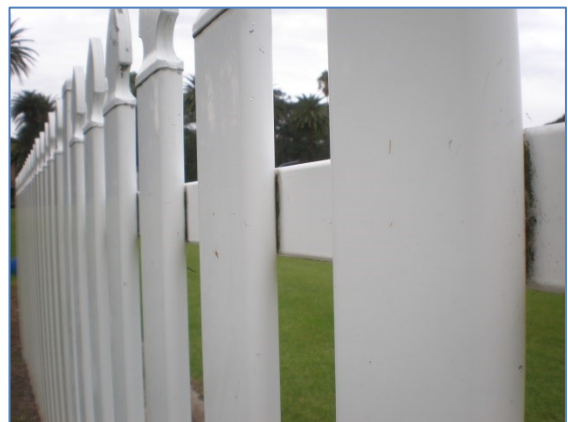
This image shows a close up of the face of the picket after cleaning. It demonstrates the color fastness of the coating and the integrity of the film adhesion to the metal substrate.

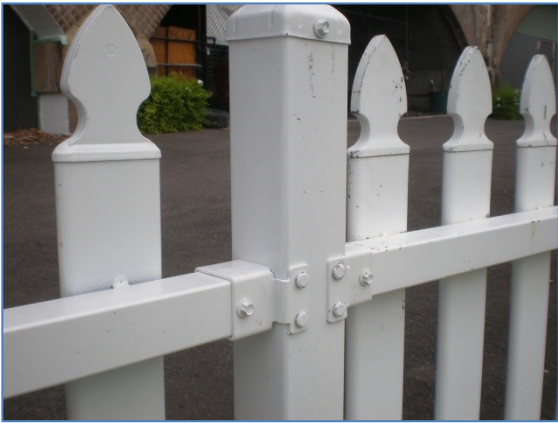
The panel (left) is a new replacement panel while the panel (right) is 10 years old.

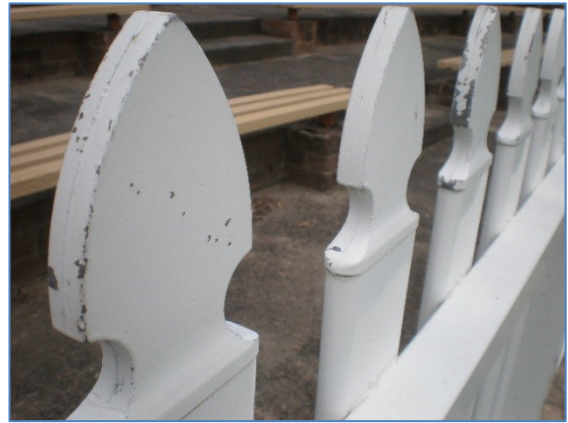
This image shows the alloy picket top at a section in front of the grandstand. The limited extent of chipping of the coating from every day use demonstrates the durability of the coating.

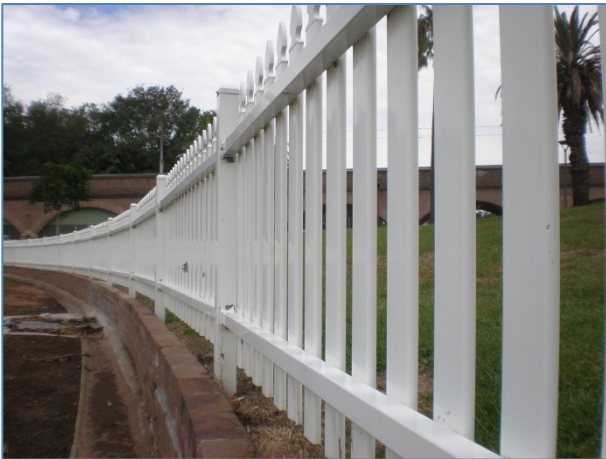
This image shows the storm water drain that results in the fence being submerged during flooding and 'king' tides.

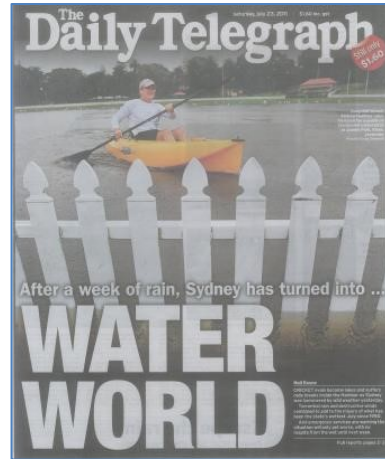
This is the front page of *The Daily Telegraph* (2011) showing the section of fencing in the image right submerged.
